BUILDING
MATERIALS
AND
STRUCTURES

REPORT BMS42

Structural Properties
of Wood-Frame Wall and
Partition Constructions With
"Celotex" Insulating Boards

Sponsored by
The Celotex Corporation

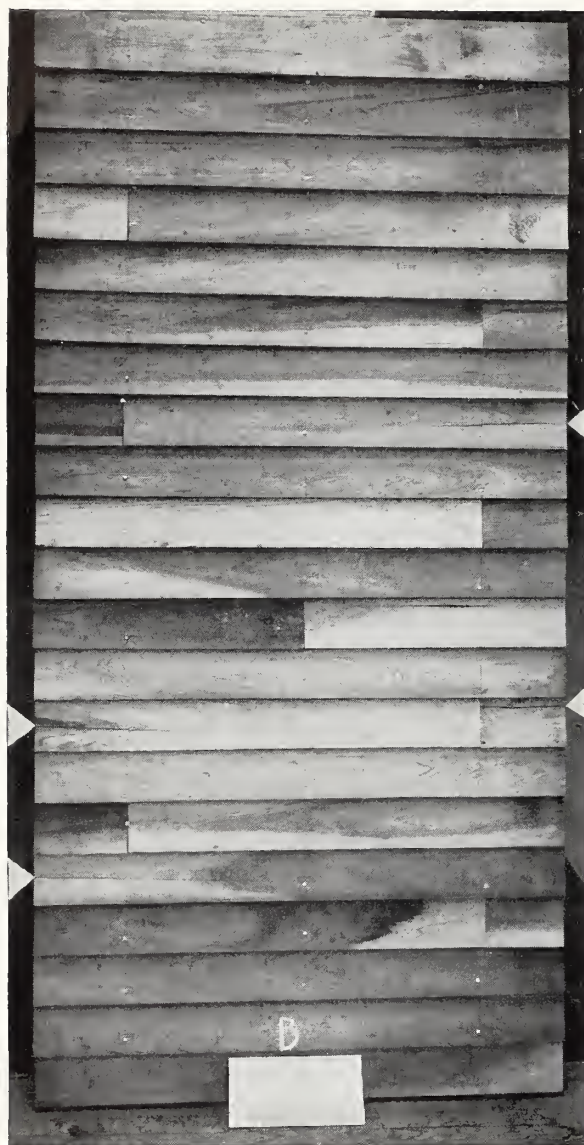
FIGURE 5.—Typical wall specimen, BX and BY.
The splits in the siding are indicated by the arrowheads.

wire nails, one at each stud. The 8d nails caused numerous splits in the siding, as shown in figure 5.

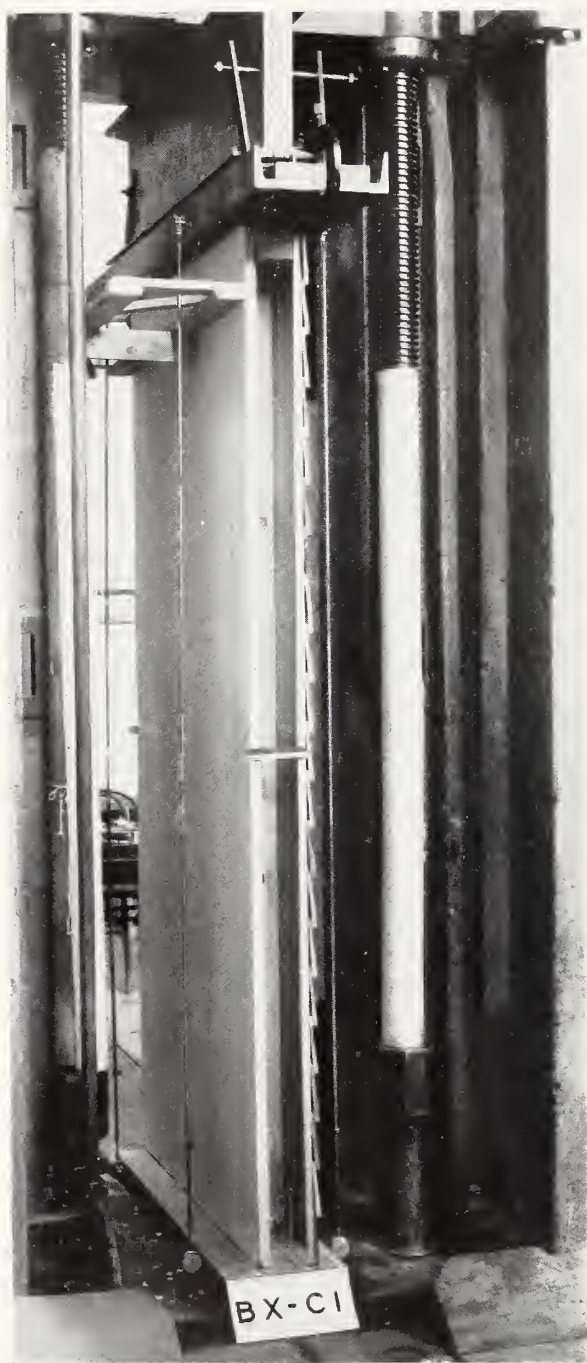
FIGURE 8.—Wall specimen BX-C1 under compressive load.

Wall specimen *BX-C1* under compressive load is shown in figure 8. The results for wall specimens *BX-C1*, *C2*, and *C3* are shown in table 8 and in figures 9 and 10.

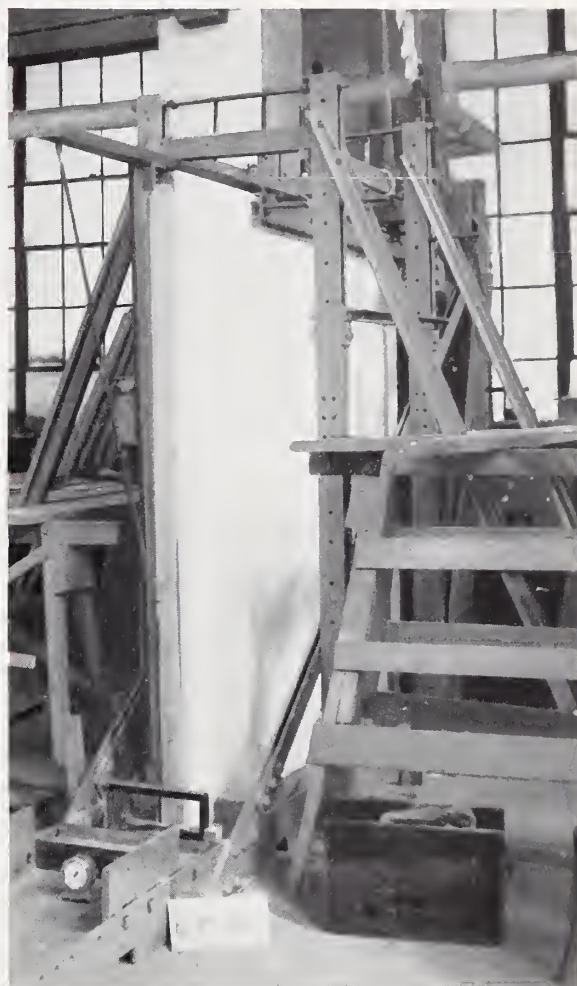
FIGURE 28.—Wall specimen *BY-R1* under racking load.

Wall specimen *BY-R1* under racking load is shown in figure 28. The results for wall

The racking loads were applied only to the top plate and the stop was in contact only with the floor plate. At loads of 1.125, 1.125, and 0.875 kips/ft on specimens *R1*, *R2*, and *R3*, respectively, there was noticeable vertical displacement of the building board at the

joint. At the maximum loads the nails along the top plate and the upper part of the edge studs pulled through the edges of the board. The nails tore through the edge of the sheathing along the edge stud which was against the stop, the vertical displacement increasing both between the two building boards and between the two sheathing boards. Also, the top plate separated from the tops of the studs.
